磁振造影安全議題

本週學習目標

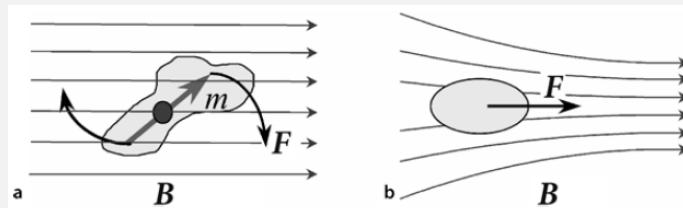
Magneto-mechanical interactions

- A uniform magnetic field: a magnetic moment experience a **mechanical torque** that align their magnetic moment parallel (or antiparallel) to the B .
- A non-uniform magnetic field: paramagnetic and ferromagnetic materials become **dangerous projectiles**.

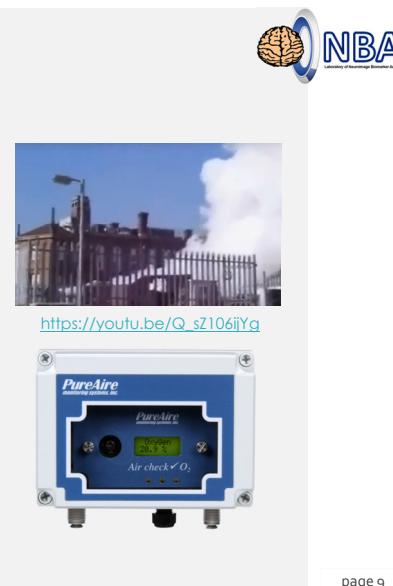
Quench

- Liquid helium is used as the cryogen achieving temperatures as low as 4 K (-269°C).
- In a scanner with a cryostat volume of 1500 liters, a spontaneous helium boil-off would liberate over 1,000,000 liters of gas.
- All systems should have **helium-venting equipment**, which removes the helium to the outside environment in the event of a quench.
- If this fails, helium will vent into the room and replace the oxygen. → **oxygen monitor!**

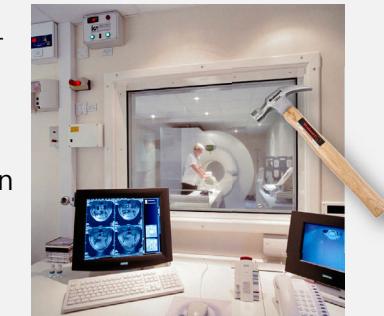
Quench

- If there is a quench pipe failure, an inwardly opening magnet room door may become sealed.
- Possible side effects from a sudden drop in oxygen level, reduced room temperature, and dramatic increase in air pressure:
 - Asphyxia
 - Hypothermia
 - Ruptured eardrums

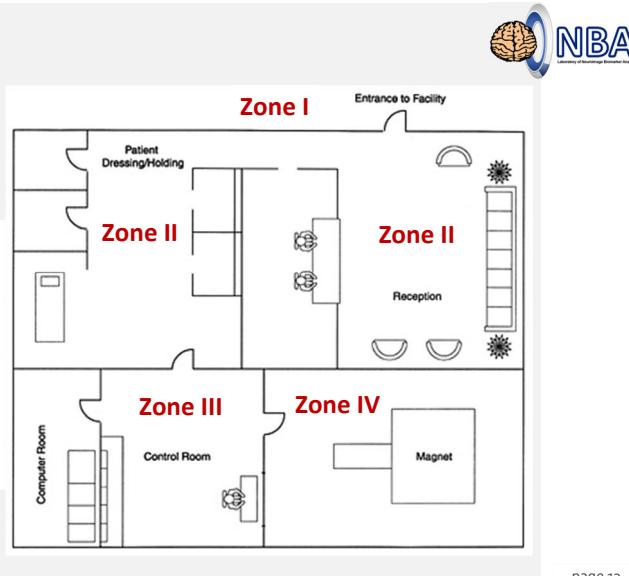
ACR Safety Zones

MRI		NOTICE	
MRI ZONE I	MRI Access Area	MRI ZONE II	MRI Patient Screening and Preparation
CAUTION		DANGER	
MRI ZONE III	Restricted Access Screened MRI Patients and MRI Personnel Only	MRI ZONE IV	Restricted Access Screened MRI Patients Under Direct Supervision of Trained MRI Personnel Only

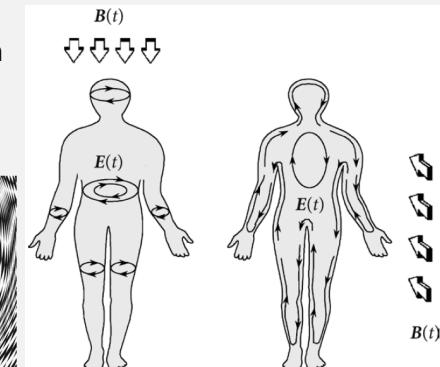
Gradients: Time-Varying Magnetic Fields

- TVMF effects include
 - peripheral nerve stimulation
 - magneto-phosphenes
 - acoustic noise

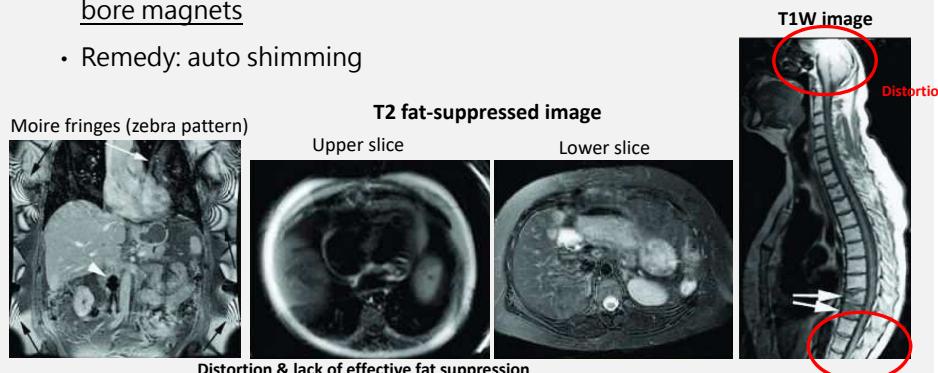
Main Magnetic Field Artifacts

- Improper shimming, environmental factors, far extremes of short bore magnets
- Remedy: auto shimming

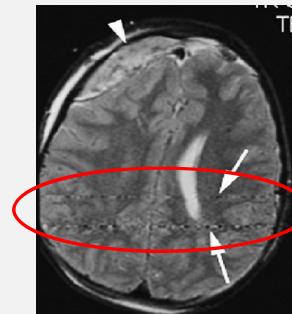
RF-related artifacts: Zipper artifacts

- Unwanted external RF noise (TV, radio station, electronic monitoring equipment)
- Occurs at the specific frequency
- Remedy: improve RF building, shut the door of MR room

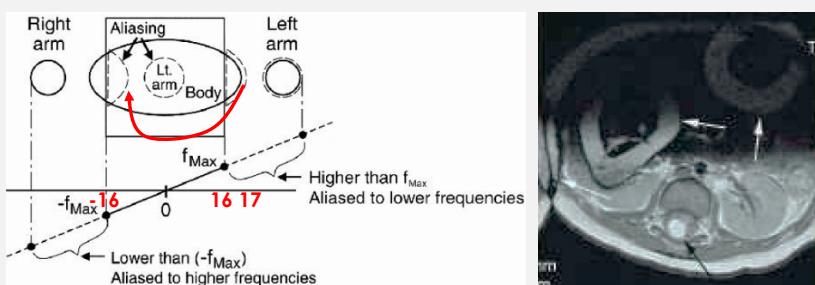
Aliasing Artifacts

- Any frequency higher than the maximum frequency allowed by the gradient cannot be detected correctly.
- $f(\text{perceived}) = f(\text{true}) - 2f(\text{max})$

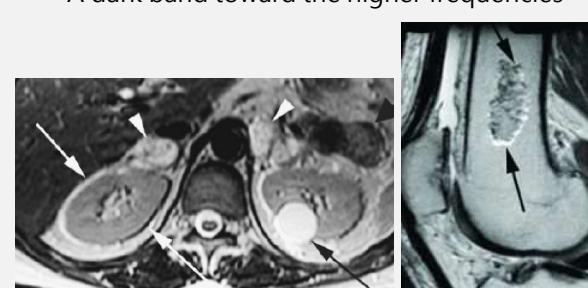
Chemical Shift Artifacts

- Chemical shift artifact only occurs in the frequency-encoding direction.
- A bright band toward the lower frequencies
- A dark band toward the higher frequencies

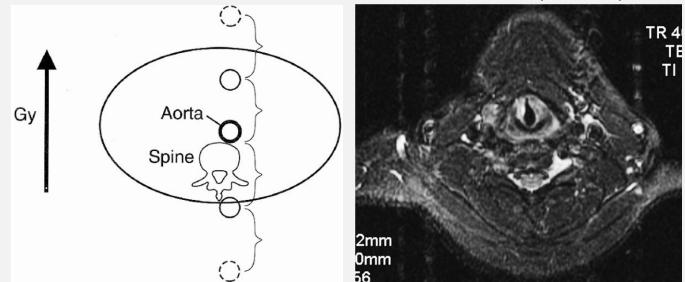
Motion Artifacts

- Ghost artifacts of the vessels are equally separated along phase-encoding direction.

- $$\text{separation (SEP in pixels)} = \frac{\text{acquisition time}}{T(\text{motion})}$$

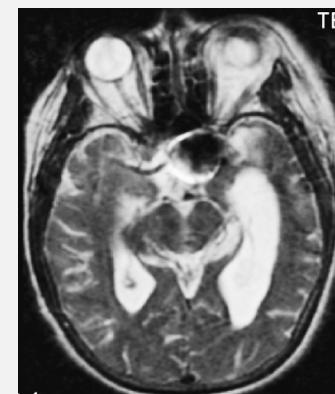
Aneurysm clip

Magnetic Susceptibility Artifacts

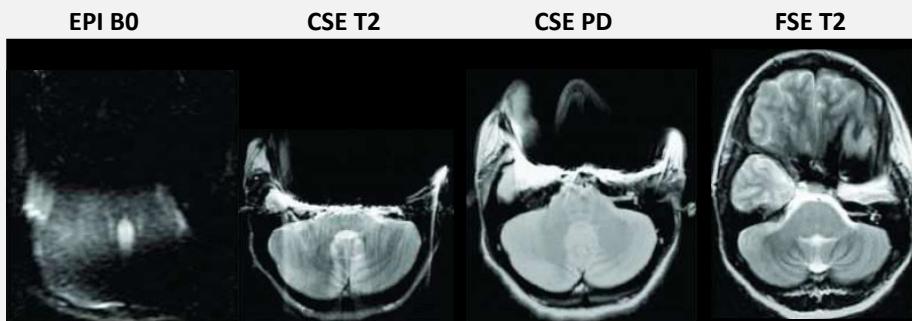
Magnetic Susceptibility Artifacts

- A patient with dental braces
